NATIONAL REGISTER OF HISTORIC PLACES
INVENTORY -- NOMINATION FORMSEE INSTRUCTIONS IN HOW TO COMPLETE NATIONAL REGISTER FORMS
TYPE ALL ENTRIES -- COMPLETE APPLICABLE SECTIONS

Salter House; CHESTERVILLE BRICK HOUSE (Preferred)

CHESTERVILLE BRICK HOUSE

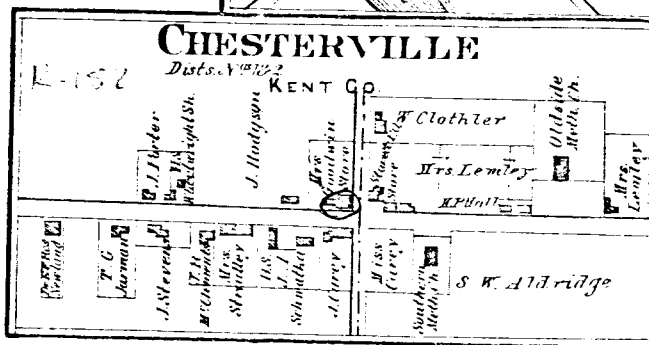
SALTER HOUSE RELOCATION
CHESTERVILLE MD.

ASSUMED LOCATION OF
SALTER HOUSE PRIOR
TO RELOCATION

PRESENT LOCATION

217.80'
N 62° 00' W

N 28° 00' E 200.00'

In the relocation, the house orientation was changed from fronting on Morgnec Road, facing south to fronting on Maryland Route 290, facing east. (See attached site relocation plan.) The building was stabilized and the masonry work restored after the move. The thirty foot, three-bay, one and one-half story frame wing with chimney and the one-story, L-shaped shed porch which turned with the highway intersection were destroyed prior to relocation. A fire in the house destroyed the original stair and damaged much of the trim. A new cedar shingle roof was put on the house after its relocation.

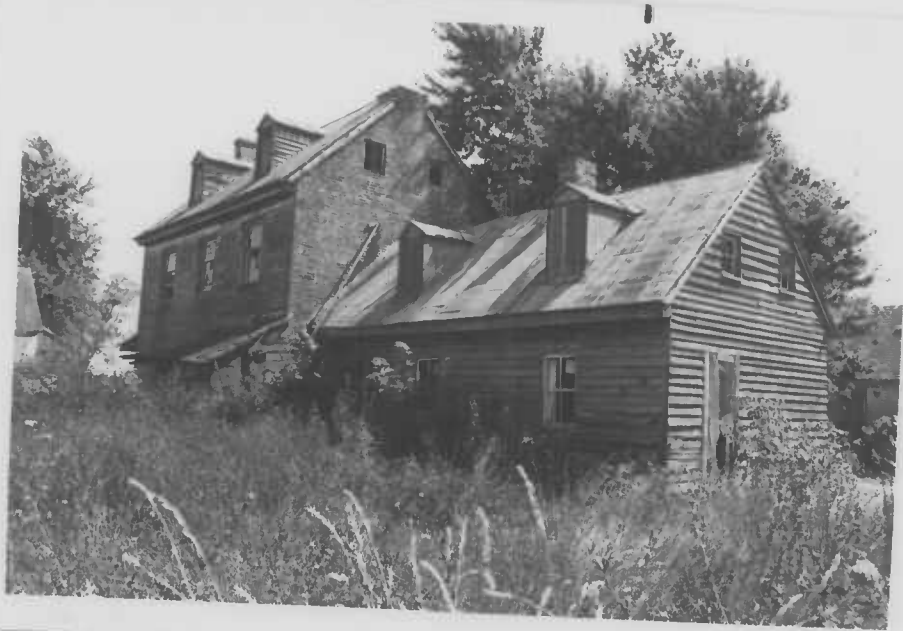
Salter House

View from NW

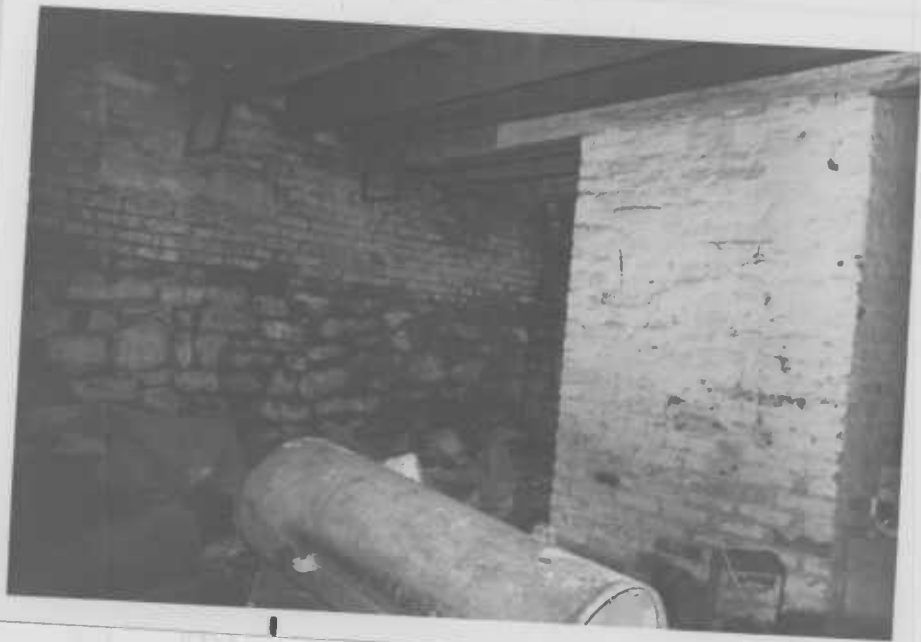
Salter House

Chimney base looking East
Cellar under frame wing

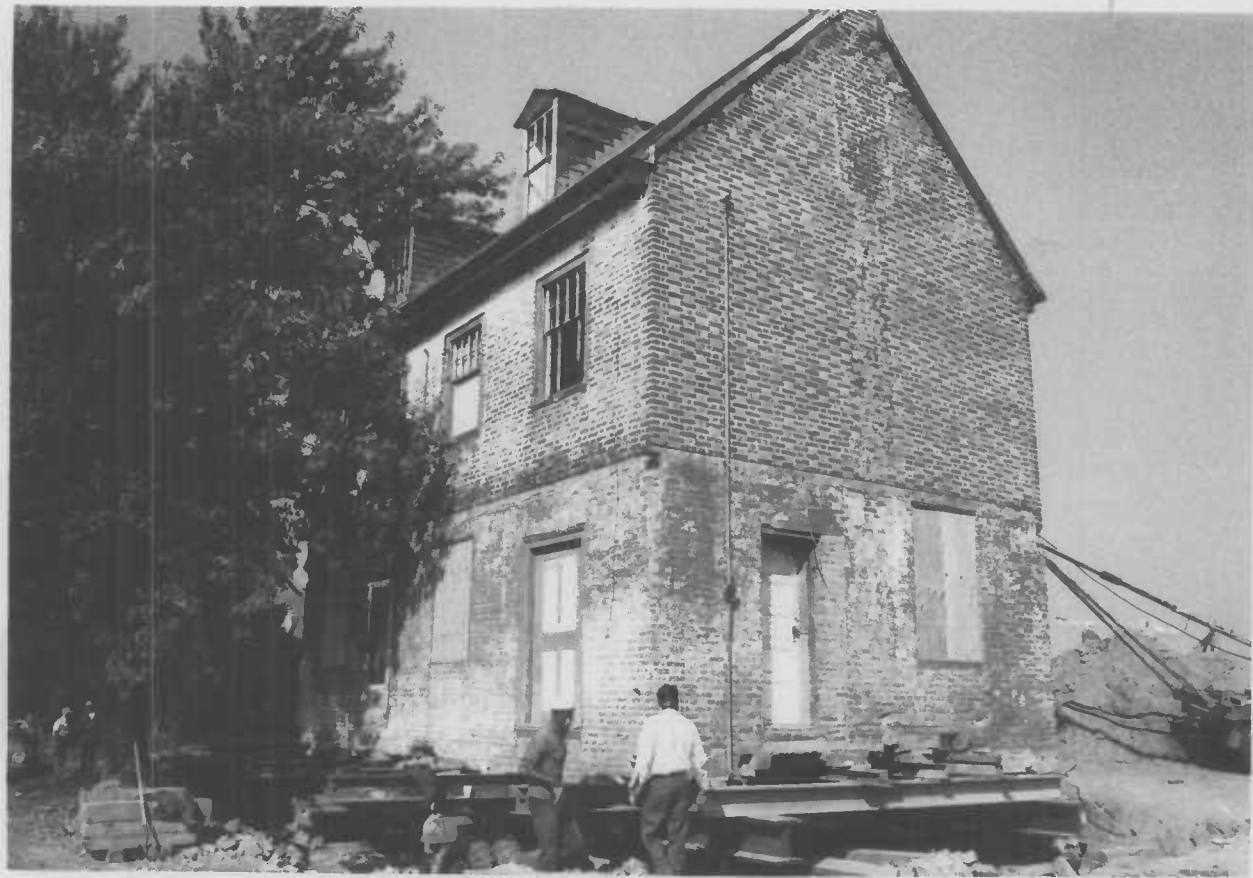
K. 182

Formerly used as a tavern, a store, and a dwelling, this reminder of Chesterville's heritage is shown en route to a safer location adjacent to its original site.
